TOWN OF NEWBURGH PLANNING BOARD TECHNICAL REVIEW COMMENTS

PROJECT NAME:HADID CLEARING & GRADING APPLICATION-34 SUSAN DRPROJECT NO.:2021-10PROJECT LOCATION:SECTION 46, BLOCK 5, LOT 21REVIEW DATE:29 OCTOBER 2021MEETING DATE:4 NOVEMBER 2021PROJECT REPRESENTATIVE:ENGINEERING & SURVEYING PROPERTIES

Re: Revised Letter Report – Geotechnical Investigation 34 Susan Drive Newburgh, New York

Re: Additional Geotechnical Review of Hadid Pool Fill at 34 Susan Drive, Newburgh, NY File No. 3977

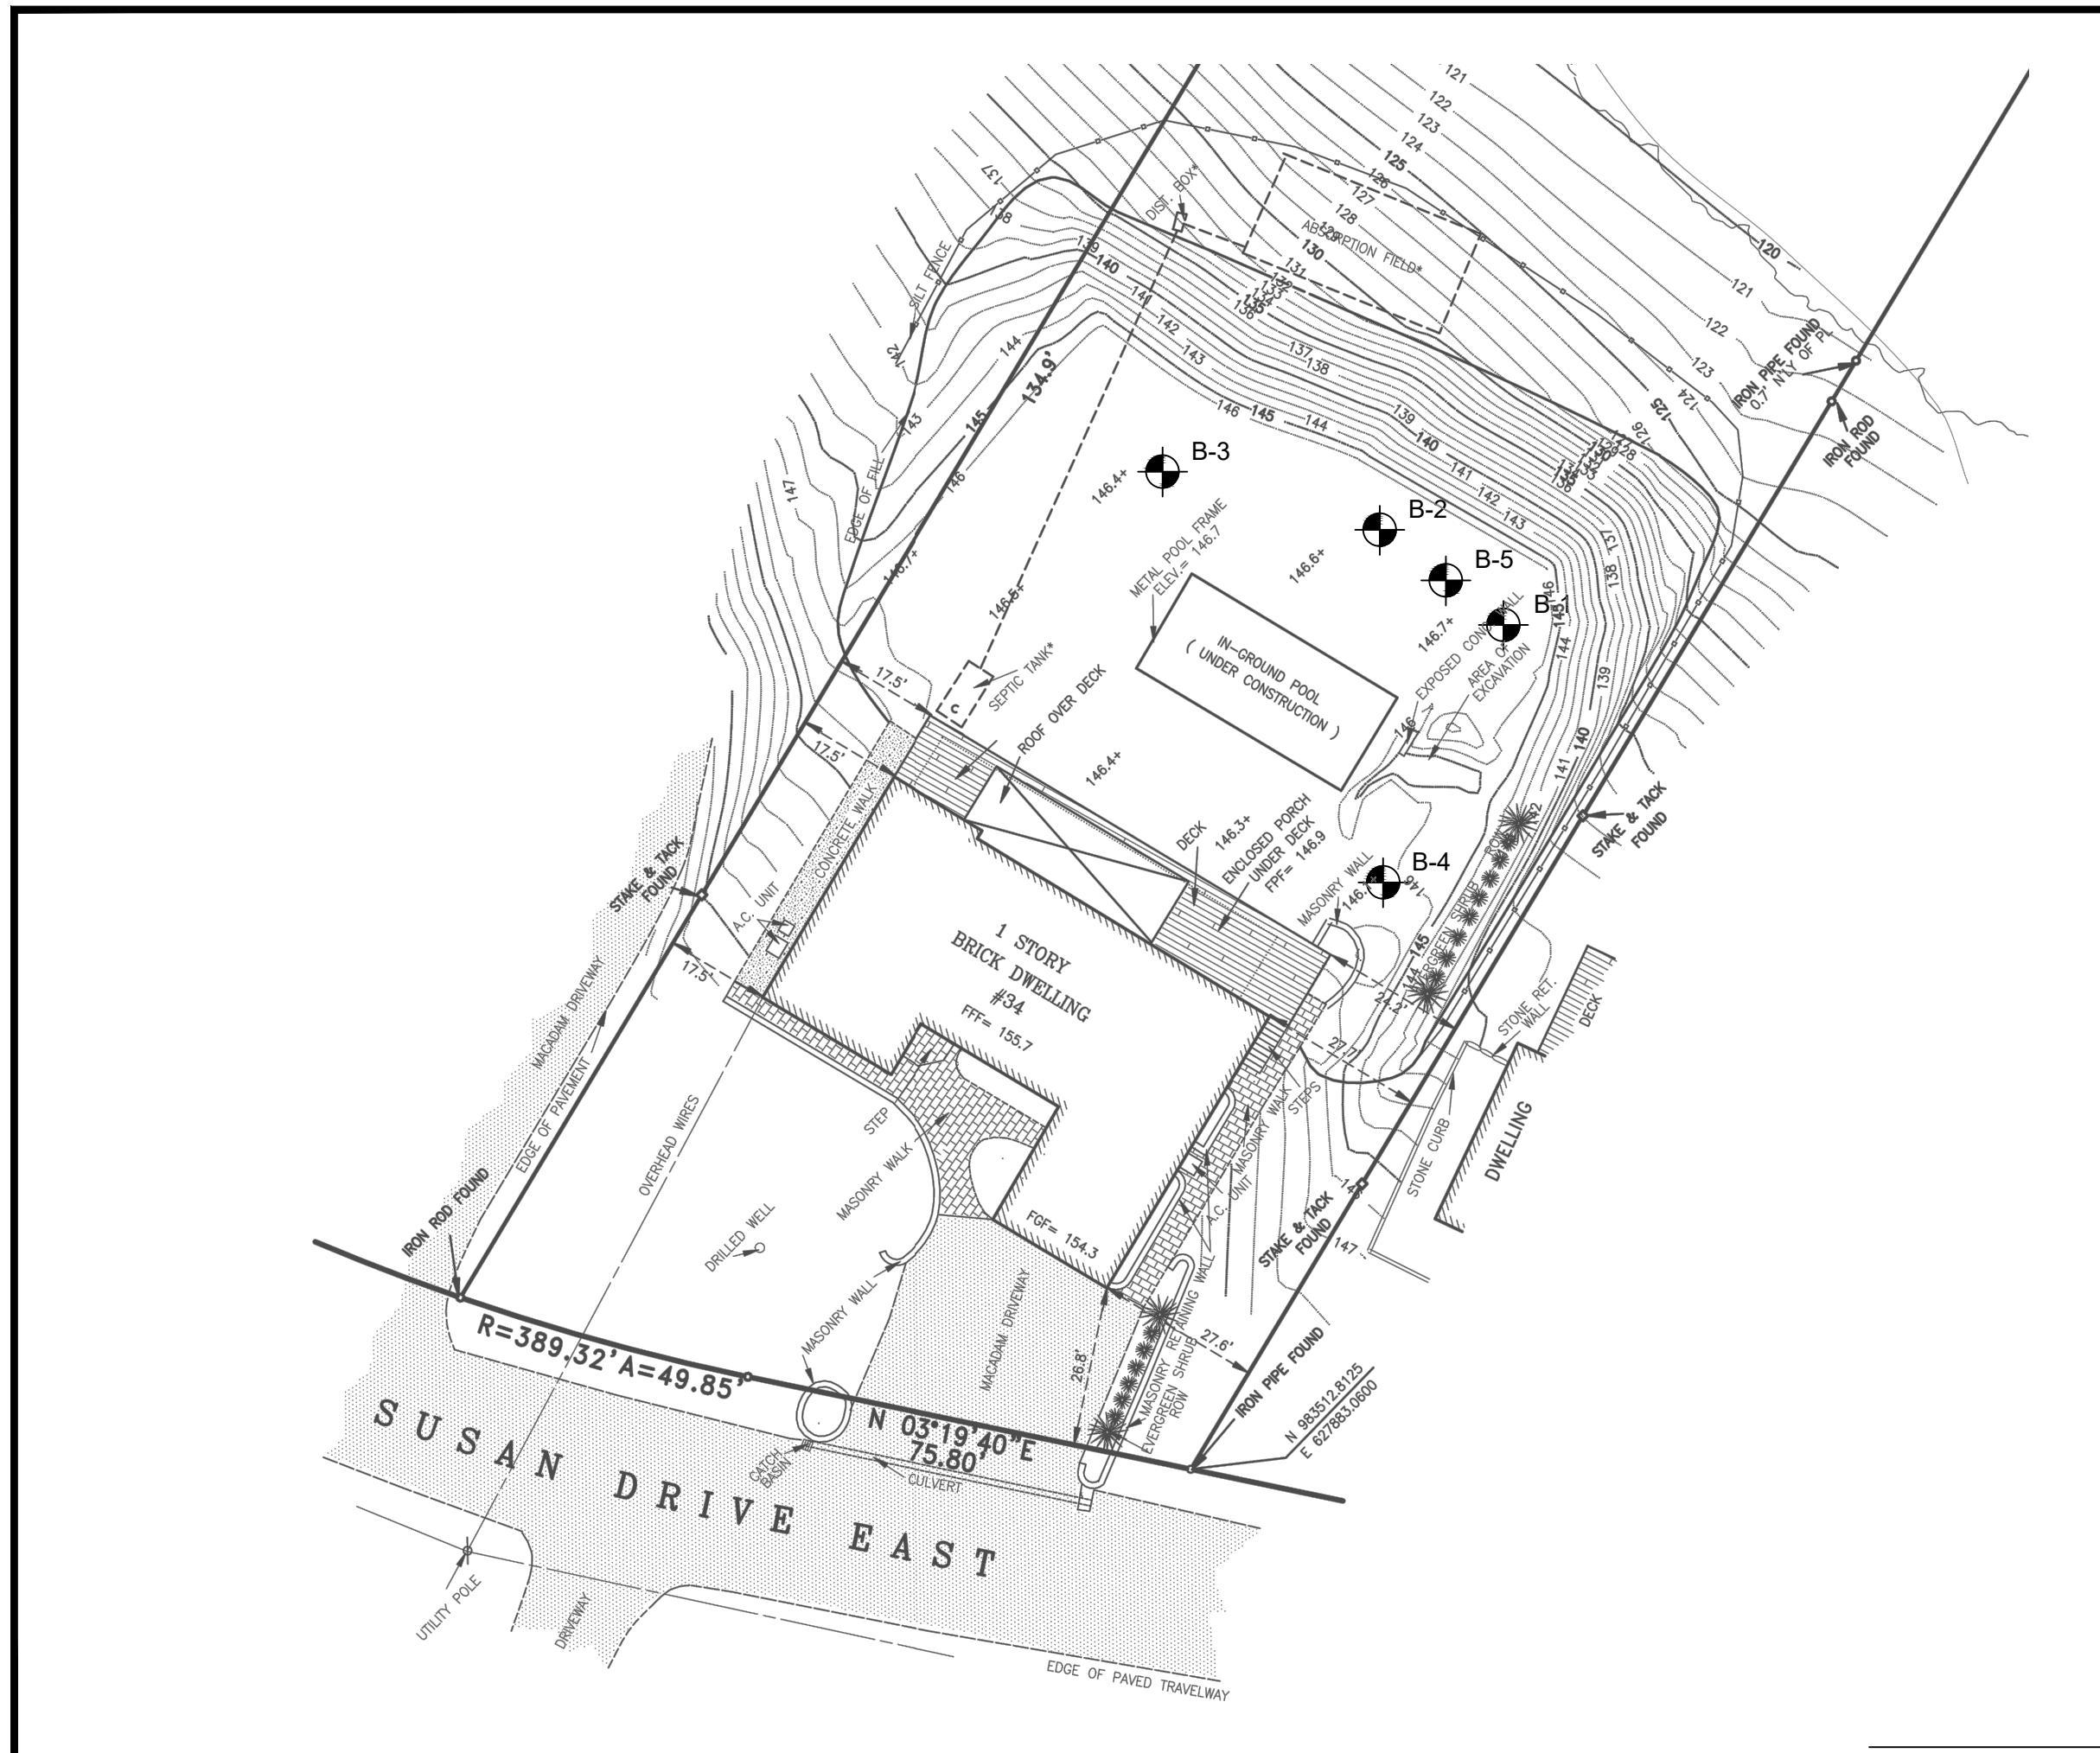
Five (5) geotechnical borings, denoted as Borings B-1 to B-5, were performed in about the locations shown on the attached Boring Location Plan in Figure 1. Borings B-1, B-2, B-3, and B-5 were performed along the eastern edge of the imported fill, while Boring B-4 was performed along the southern edge of the fill layer. The borings were performed by Municipal Testing Laboratory (MTL) of Hauppauge, NY using a GeoProbe 3100GT Truck-Mounted Drill Rig from July 19 to 20, 2021. Boring locations were selected in the field by GES, and were continuously inspected by Mr. Michael Torino, P.E. of GES. Typed boring logs are attached to this Letter Report, as are laboratory test results, discussed below.
