**TOWN OF NEWBURGH
PLANNING BOARD
TECHNICAL REVIEW COMMENTS**

PROJECT NAME: SCANNELL-NEWBURGH COMMERCE CENTER
PROJECT NO.: 2021-21
PROJECT LOCATION: SECTION 95, BLOCK 1, LOT 58
REVIEW DATE: 25 FEBRUARY 2022
MEETING DATE: 3 MARCH 2022
PROJECT REPRESENTATIVE: LANGAN ENGINEERING

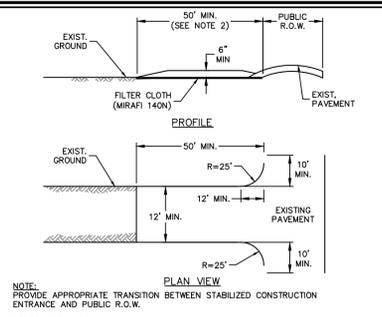
STABILIZED CONSTR. ENTRANCE
SCALE: NTS

- WHEN WASHING IS REQUIRED, IT SHALL BE DONE ON AN AREA STABILIZED WITH STONE AND WHICH DRAINS INTO AN APPROVED SEDIMENT TRAPPING DEVICE.
- PERIODIC INSPECTION AND NEEDED MAINTENANCE SHALL BE PROVIDED AFTER EACH RAIN.

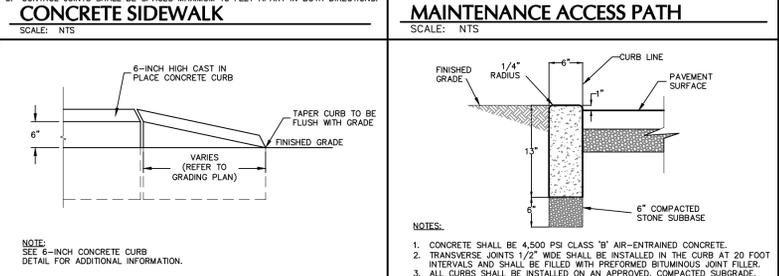
CURB TERMINATION
SCALE: NTS

NOTE: SEE 6-INCH CONCRETE CURB DETAIL FOR ADDITIONAL INFORMATION.

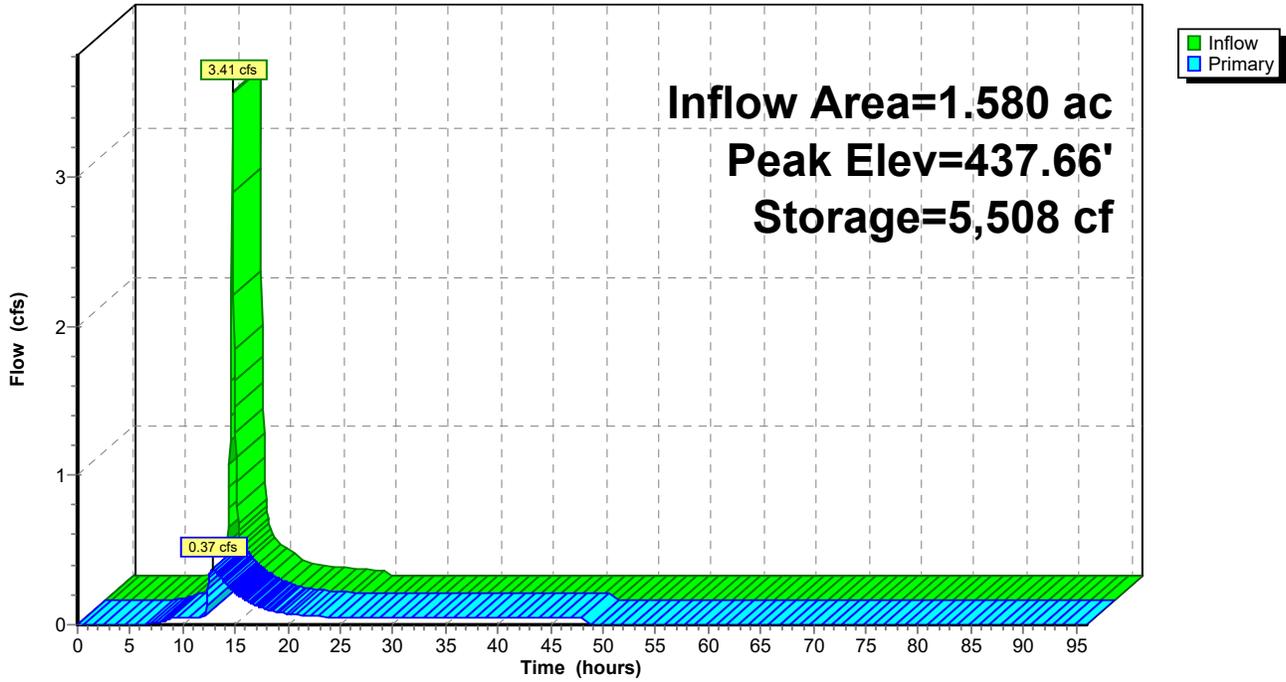
2021-11-08 Proposed Conditions - Building to Bio Type III 24-hr 10-yr storm Rainfall=5.50"

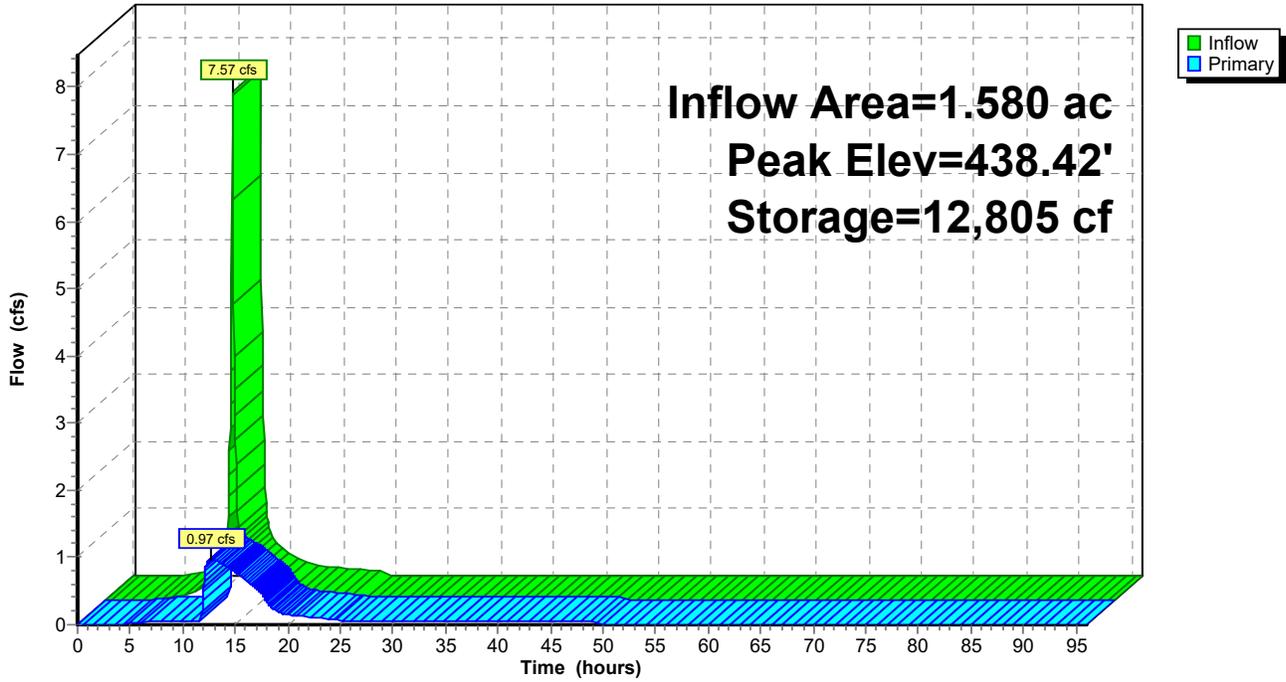
2021-11-08 Proposed Conditions - Building to BioType III 24-hr 100-yr storm Rainfall=8.37"

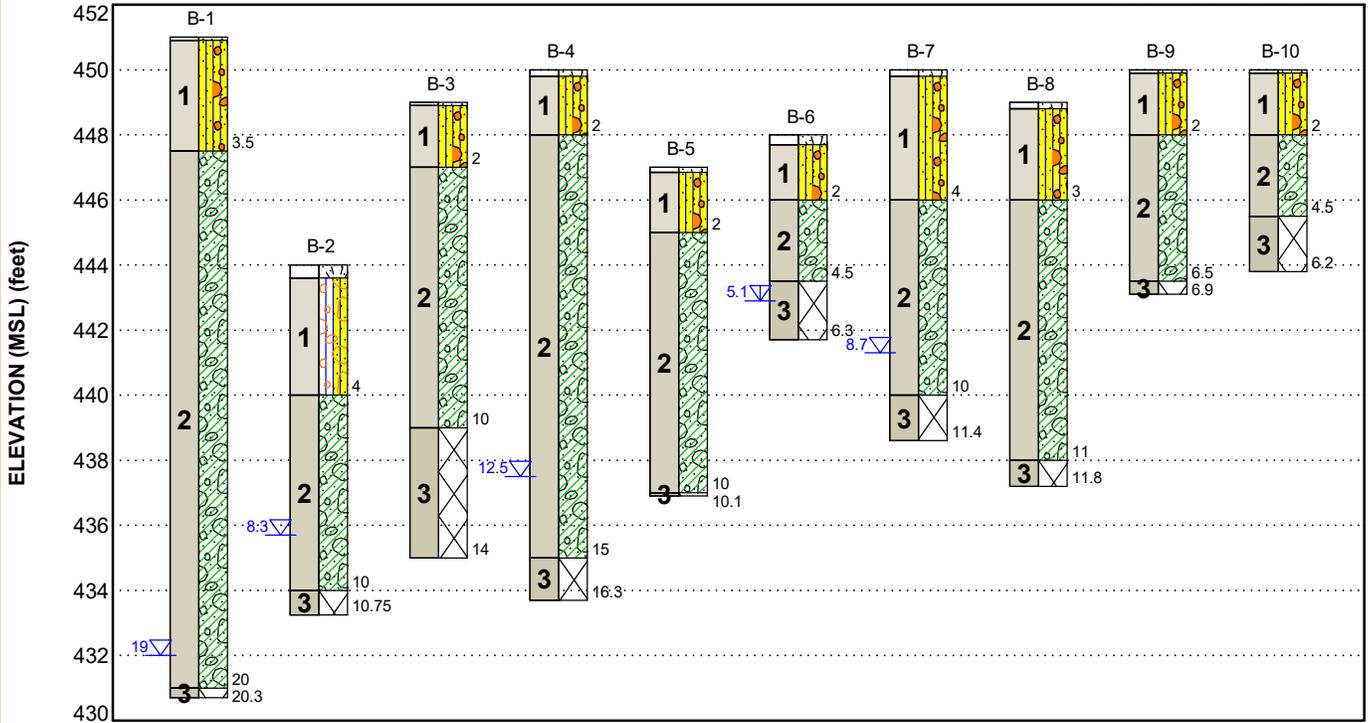
This is not a cross section. This is intended to display the Geotechnical Model only. See individual logs for more detailed conditions.

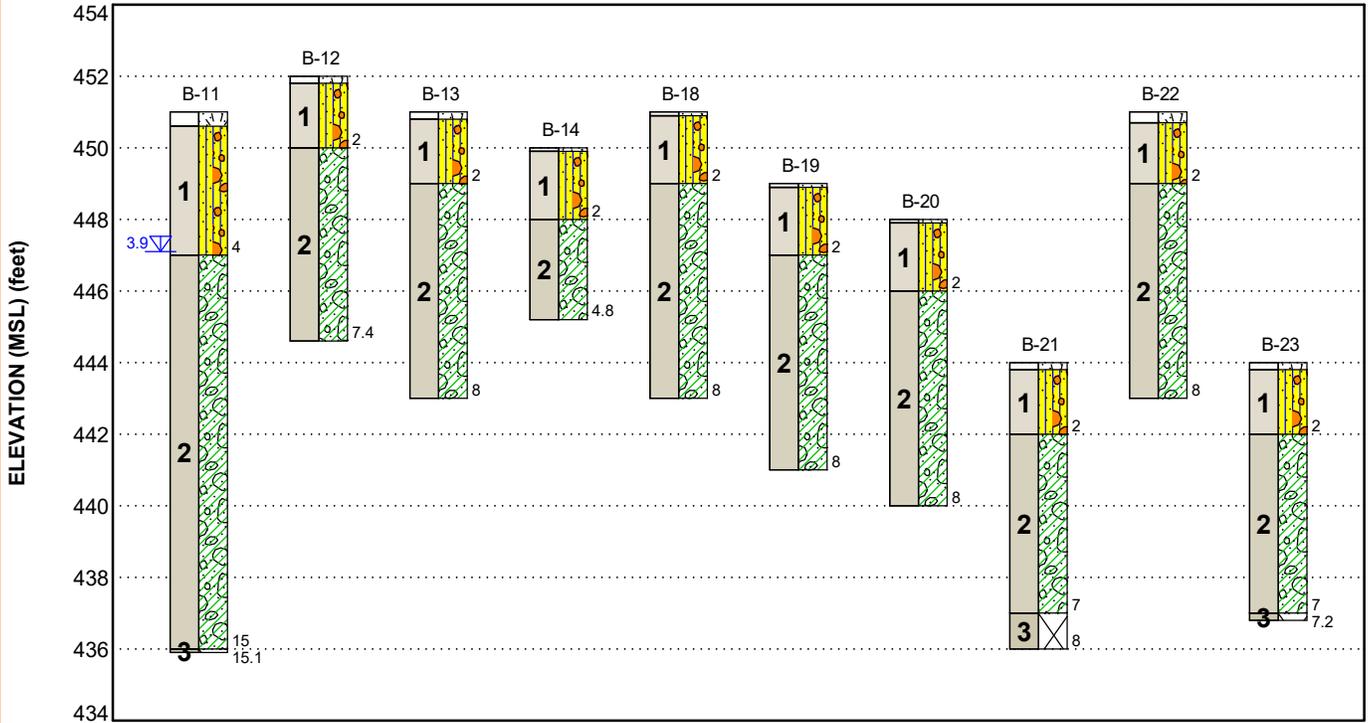
This is not a cross section. This is intended to display the Geotechnical Model only. See individual logs for more detailed conditions.

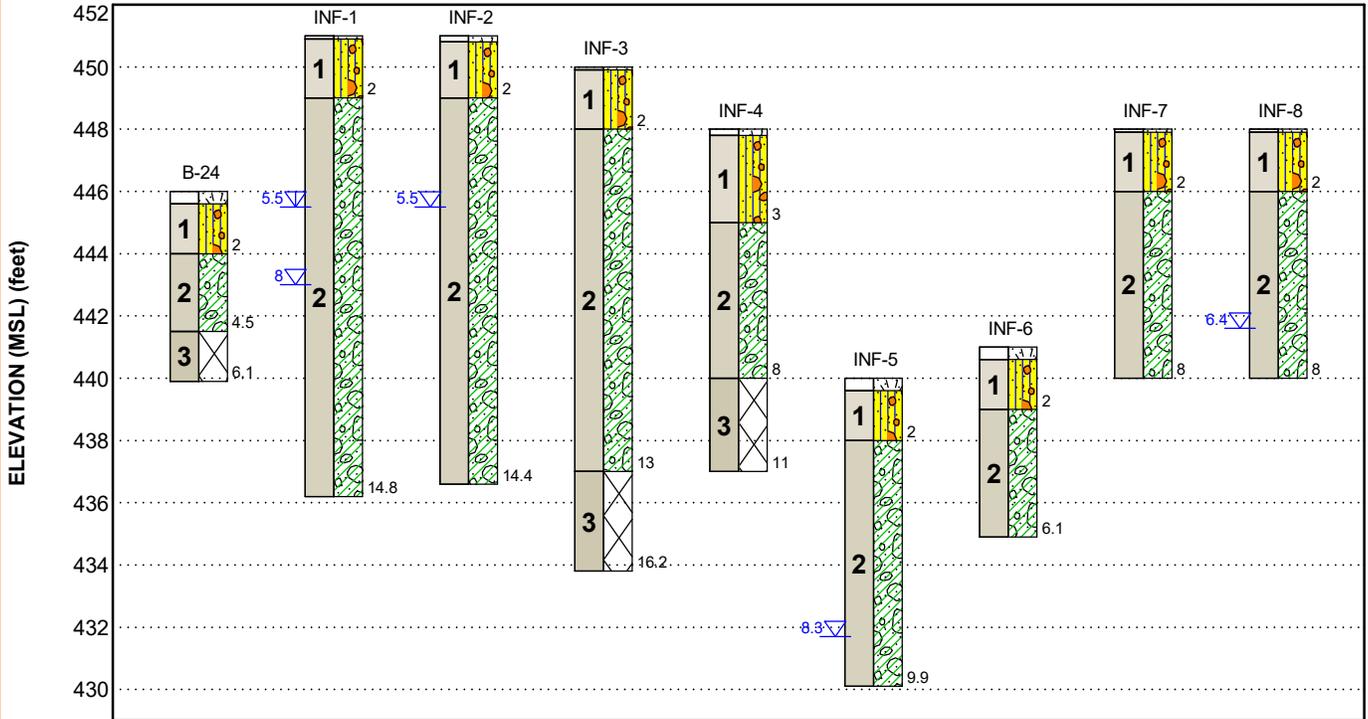
This is not a cross section. This is intended to display the Geotechnical Model only. See individual logs for more detailed conditions.

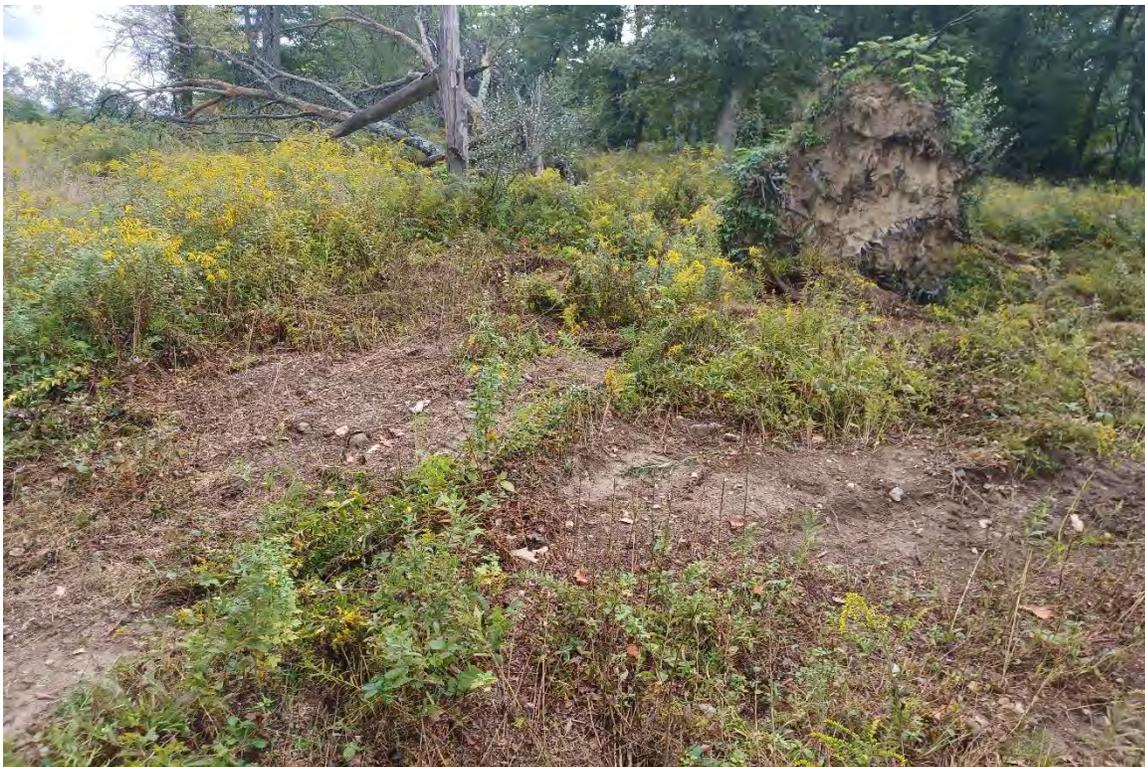
Photo 6: The landscape along the eastern boundary has been graded and leveled. View to the north.

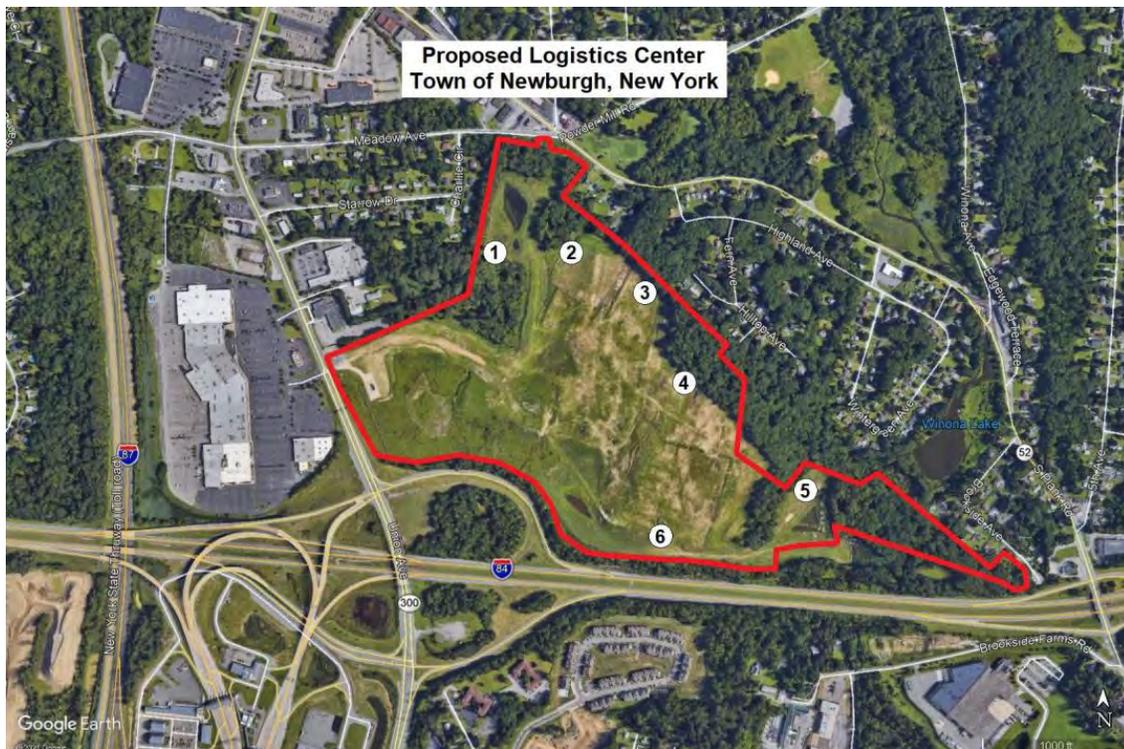
Figure 1 — Google Earth image showing the proposed logistics center site and vicinity in the Town of Newburgh, NY. The site property line is approximately outlined in red. Ambient sound survey Locations also shown.

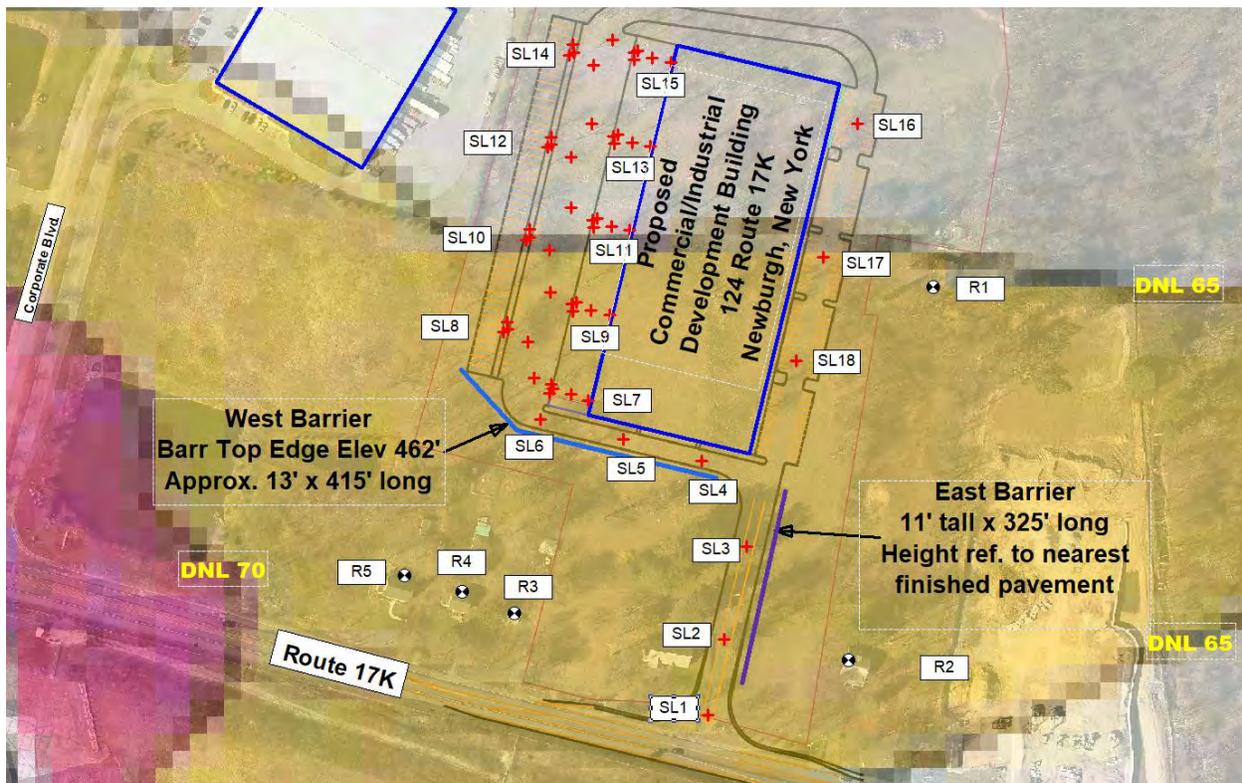
Figure 6. Recommended West and East sound barrier wall
Proposed Commercial/Industrial Development, Newburgh, NY

Barriers screening source sound have decreased the maximum sound level to 57 dBA (excluding sound produced by trucks entering/exiting Route 17K). This level corresponds to an energy average sound level of 42 dBA, well within the NYSDEC guideline of 50 dBA.
